TECHNICAL REPORT ARCCB-TR-99016

**GRAY LAYERS AND THE EROSION OF  
CHROMIUM PLATED GUN BORE SURFACES**

**PAUL J. COTE  
CHRISTOPHER RICKARD**

SEPTEMBER 1999

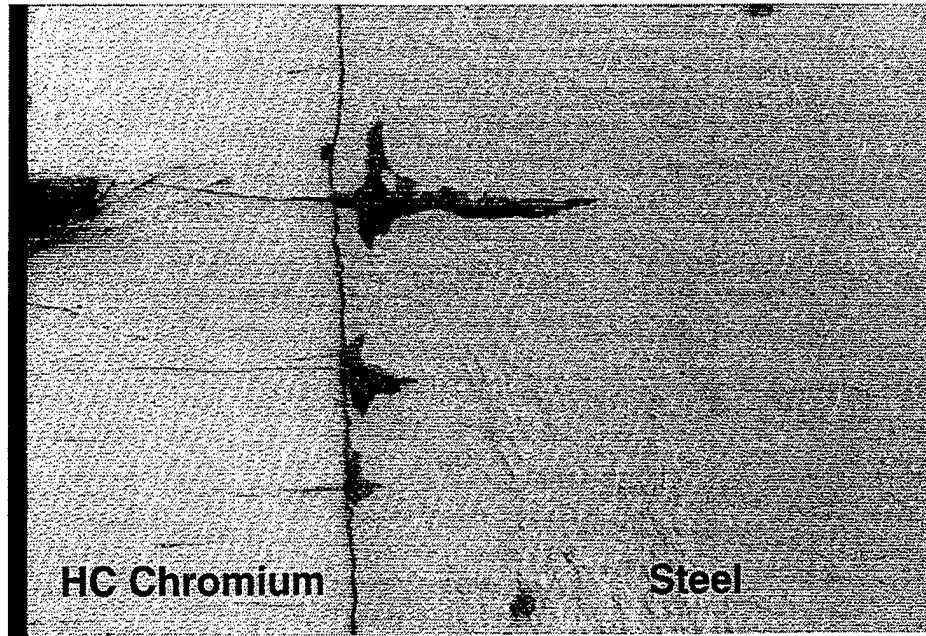
**Original 2000X**

Figure 1 is a photomicrograph showing erosion damage of specimen 1 at the chromium/steel interface after about 1200 conventional rounds. The dark areas at the tips of the chromium cracks are gas-steel reaction products. An unetched specimen was examined to more clearly delineate the reaction product, which appears as a solid gray material under optical microscopy. Metal attack clearly occurs via gas ingress through the fine cracks in the chromium plate. Energy dispersive spectroscopy indicates that the gray material is a mix of iron oxide and iron sulfide.

Another observation reflected in Figures 1 through 3 is that the decomposition pits can join up along the steel/chromium interface as the pits grow into the steel. Such chemical attack is obviously a major disbonding mechanism for chromium spallation.

Figure 1. Micrograph of an unetched section of specimen 1 showing the chemical attack on steel. Note fissures are present within the steel reaction products.

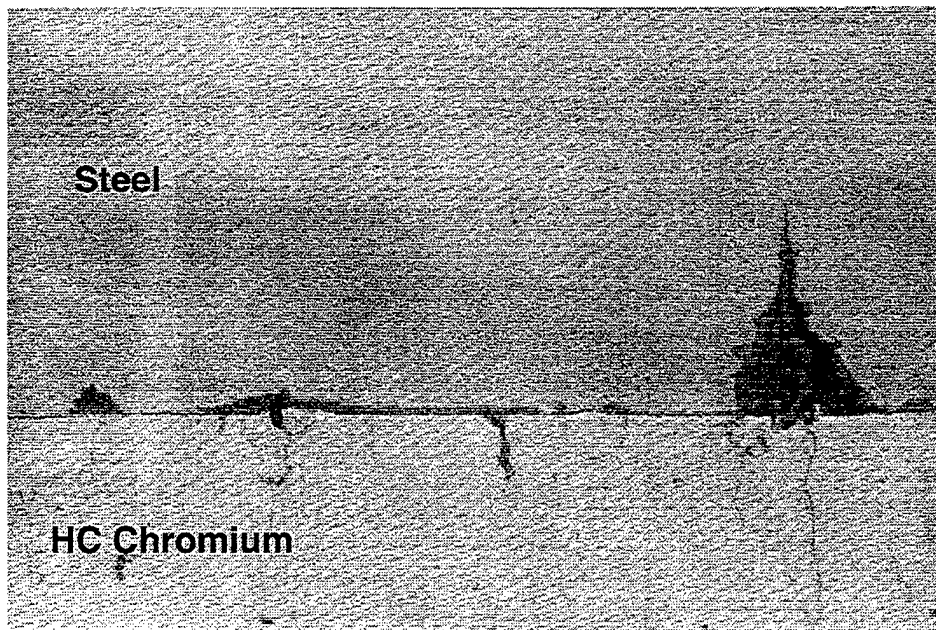
**Original 500X**

Figure 2 is an unetched micrograph from specimen 2 after approximately 80 high-temperature experimental rounds. The figure shows that the gas-steel reaction product can, in some instances, extend for large distances along the interface.

Figure 2. Micrograph of an unetched section of specimen 2 showing the chemical attack along the interface.

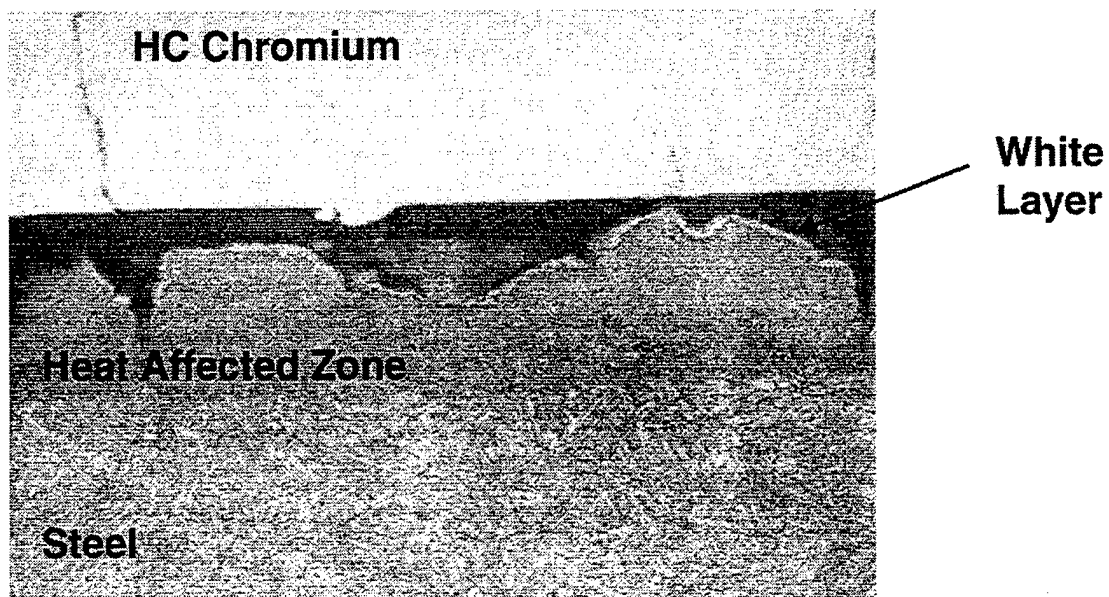
**Original 500X**

Figure 3 is a micrograph of an etched section from specimen 2. There is substantial removal of the gray material from the etching process (demonstrating that this is not a white layer), so that the pitting becomes more clearly defined. A heat-affected zone is seen in this micrograph. It can also be seen that a true white layer exists at the interface between the gray material and the steel. The white layer is only observable within heat-affected zones after etching. The gray material is partially removed by the etching process known as a Nital etch. The gray material is also removed by exposure to a drop of concentrated phosphoric acid, which leaves the surrounding steel and white layer unaffected. This ready attack by weak acid solutions is further evidence of a steel reaction product.

Figure 3. Micrograph of an etched section of specimen 2 showing dissolution of reaction products, heat-affected zone, and white layer.

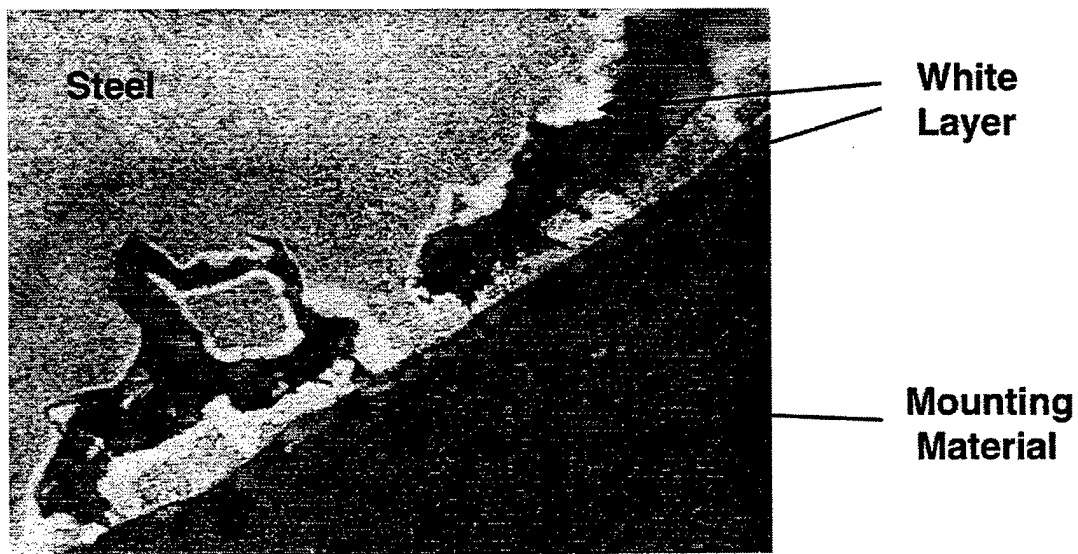
**Original 500X**

Figure 4 is a micrograph of a severely eroded area from specimen 2. There is a total chromium loss at this area, and the erosion process removed approximately a 5-mm layer of the steel at this location. A thin white layer can be seen at the steel surface, and extensive white layer formation occurs around the deep pits in the steel. This is known to represent fine-grained retained austenite stabilized by carbon and nitrogen with precipitates (primarily carbides) distributed throughout the retained austenite. The reaction products that form in the protected regions beneath the chromium a few millimeters away, as shown in Figure 3, are absent in this highly eroded area.

Figure 4. Micrograph of an etched section of specimen 2 where the chromium and an approximately 5-mm layer of steel beneath the chromium had been removed by erosion.

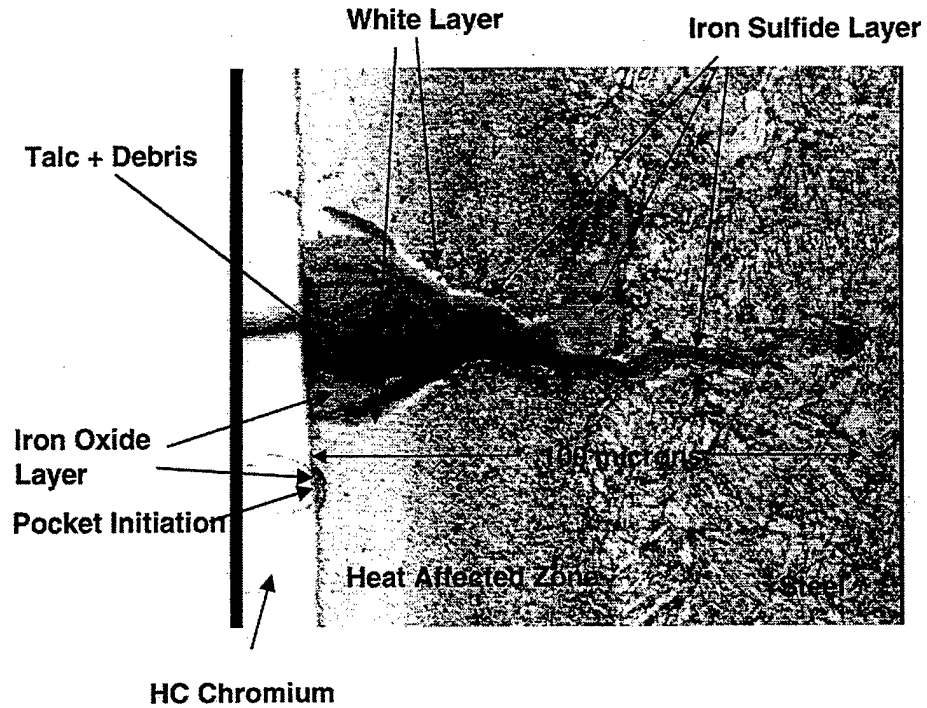
Figure 5 is a micrograph of an etched section from specimen 2 that was used for EDS chemical analysis. The chemical composition shows that the indicated compounds occur as part of the gray decomposition products. The white layer forms as a thin bright layer at the steel surface. It is known to be an austenite layer in the steel with carbide precipitates. Immediately adjacent to this white layer is an iron sulfide layer, which runs all along the pit surface and extends to the blunt tip of the pit, well beyond the heat-affected zone. The depth of the corrosion pit in the steel is approximately 100 microns. The reaction product covers the entire surface and thus forms at high temperatures during firing. At the core of the pit is a zone of iron oxide with

no evidence of sulfide. A mixture of talc and other debris is also seen in the core region in this case. Similar features are seen in all the other erosion pits on this specimen. Occasionally iron oxides and iron sulfides appear to be mixed together. The small pocket reaction zone at the tip of the fine chromium crack in Figure 5 shows the earliest stages of chemical attack. Only iron oxide is observed in this case. The initial progress of chemical attack radially into the gun tube appears to occur through fissures in the thick oxide or sulfide layers.

Figure 5. Micrograph of an etched section of specimen 2 indicating the chemical compositions deduced from EDS analysis.

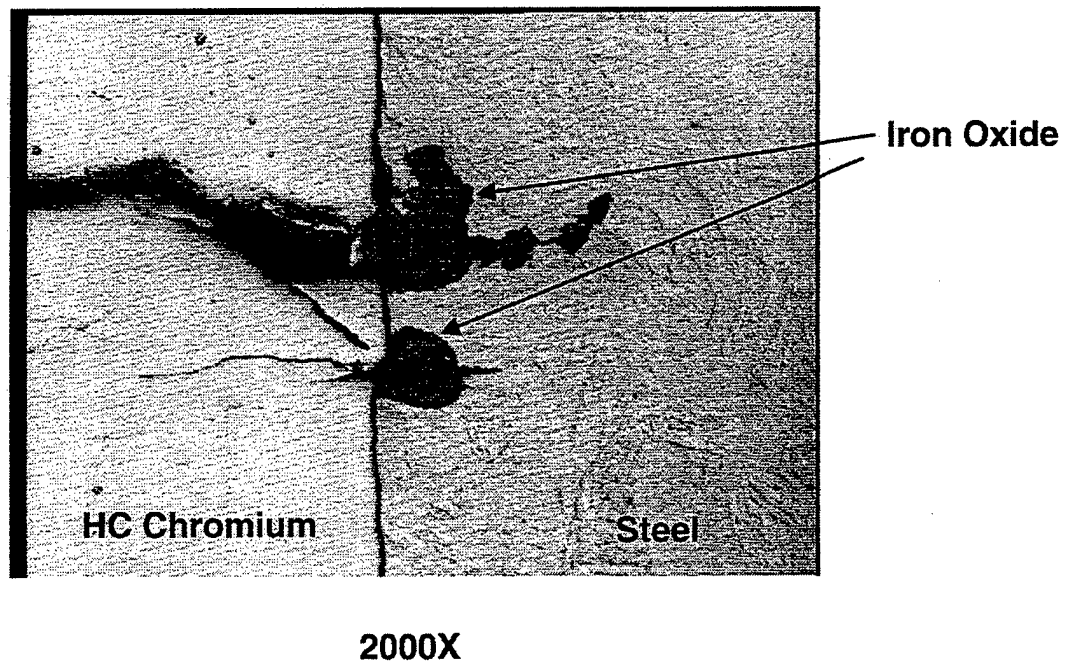
Figure 6 is a micrograph of an unetched section from specimen 3 (120-mm, 424 conventional rounds—approximately an equal mix of M829 and M829A2 rounds). Again the features are the same with gray reaction zones at the tips of the chromium microcracks. Energy dispersive spectroscopy shows the gray zones contain only iron oxide.

Figure 6. Micrograph of an unetched section of specimen 3 depicting different stages of chemical attack.

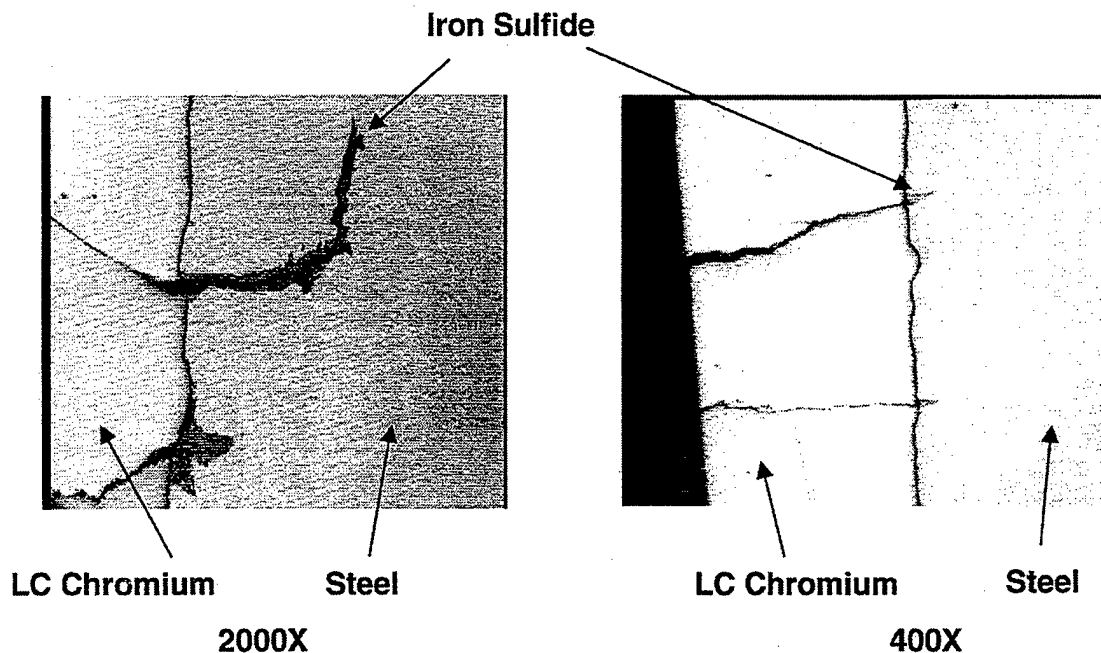
Figure 7 consists of micrographs of an unetched section from specimen 4 at 2000X and 400X. This section is from the LC plated 155-mm specimen. The numerous fine embedded cracks that occur between the major cracks with HC chromium are absent. In this case, the gray layers often exhibit a distinct yellow tint. Energy dispersive spectroscopy shows only iron and sulfur, indicating that the gray/yellow reaction zones are sulfides. The sulfur likely originates from the potassium and/or sodium sulfate used as a flame suppressant in the 155-mm.

Figure 7. Micrographs of specimen 4 at 2000X and 400X showing initiation and propagation of chemical attack.

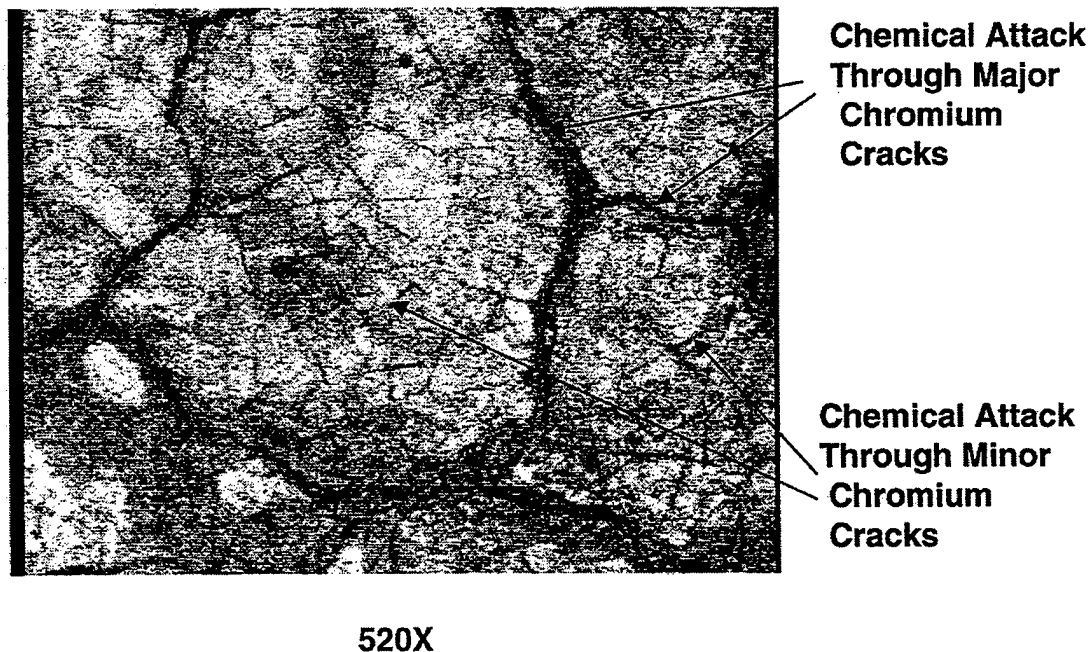
Figure 8 is a micrograph of the bore surface from specimen 2 where all of the chromium coating has been electrochemically stripped away from the steel substrate. It is seen that the entire array of large and small cracks that are present in the chromium are replicated in the erosion pattern in the steel. From this specimen orientation, all of the major fracture-like features in the steel are also solidly filled with the same dark glaze-like material (along with many of the fine crack-like features). This supports the observations regarding crack filling described above. From the previous analysis of the same tube, the dark fill material is known to be predominantly talc.

The original chromium layer in Figure 8 was heavily spalled prior to stripping this specimen. The nature of the spalling is a removal of numerous individual islands of chromium whose boundary is determined by the major chromium cracks. In the initial stages of spallation, the chromium has the appearance of being heavily pitted with many small pits visible without magnification. After stripping away the chromium, there is no evidence of pitting or spallation extending into the steel substrate; thus, the spallation of the chromium does not originate by fracture of the steel. This is in accordance with LCSM inspection of dozens of spalled regions, which show the depth of the spalls extending no deeper than the chromium/steel interface zone. Usually, in both the LC and HC specimens, fragments of chromium are observed adhering to the steel at the flat bottom of the spalled regions showing that the spallation originated from metal failure in the chromium or at the chromium/steel interface region.

Figure 8 also shows that the erosion of the steel occurs as closed paths around rounded chromium islands. These paths extend into the steel as chemical attack drives the "heat-checking" process through the chromium cracks and into the steel. It has been observed that the depth of penetration of damage can be orientation-dependent (ref 5).

The propagation of damage through the chromium and into the steel is clearly by chemical attack of the steel beneath the chromium. Figure 8 illustrates that the damage to the steel substrate is a high-temperature etching process so that the chromium plate serves, in effect, as an etching mask. Chemical attack forms relatively large, often isotropic volumes of reaction product at the chromium crack tip. The terms "pocket erosion" and "mushrooming" have been coined for the advanced stages of this phenomenon (ref 1) in gun tubes. A similar phenomenon, termed "ballooning oxidation," occurs with hot corrosion beneath coating cracks in gas turbines (ref 12). There are also indications that the gray layers can propagate along grain boundaries by occasional observations of fine lines of gray reaction products extending from the main erosion pits.

Figure 8. Micrograph of specimen 2 steel/chromium interface plane after electrochemical removal of all chromium in this area. Note the depth of penetration of the corrosion zones into the steel should vary roughly with the widths of the corrosion gaps at the surface.
